"DAMAGE TO SOLIDS CAUSED BY CAVITATION"

Royal Society Discussion on Deformation of Solids Due to
Liquid Impact

Frederick G. Hammitt *

Department of Nuclear Engineering

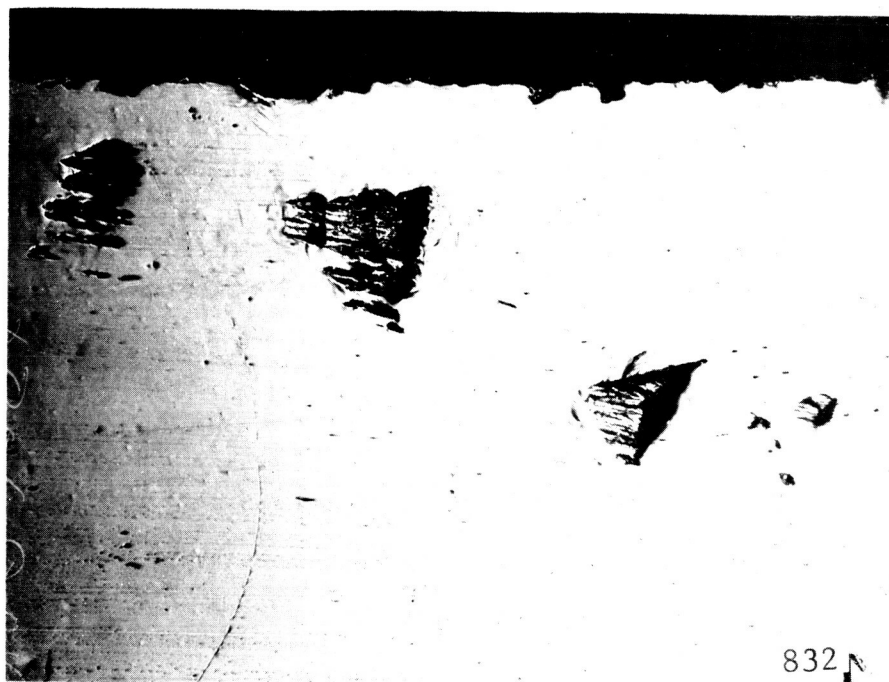
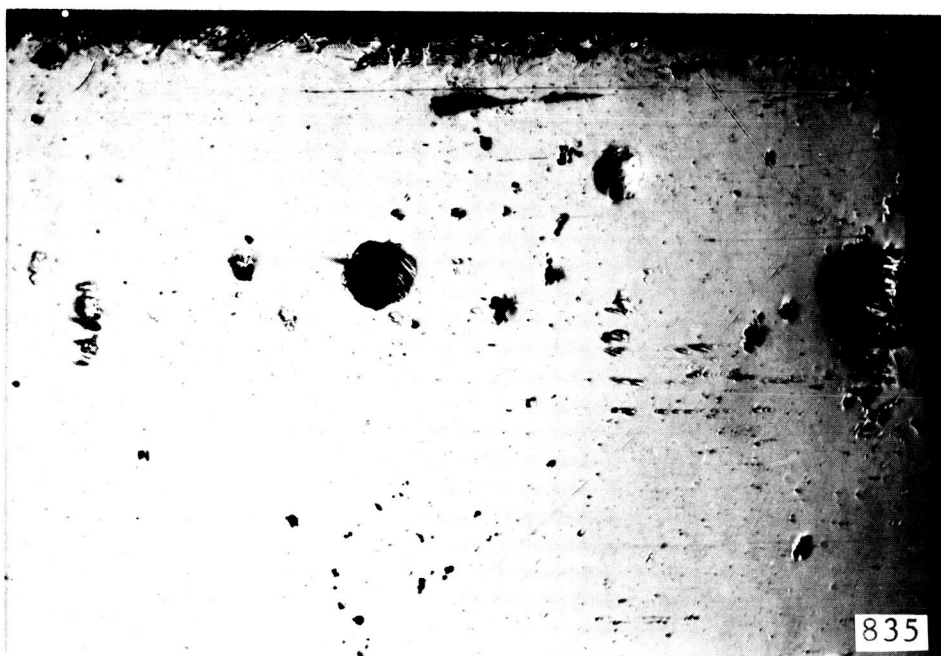
FIGURE 2. Development of Cavitation Damage at Two Locations on 302 Stainless Steel Specimen with Water, (a) 15 hrs, (b) 30 hrs.

Fig. 2 and 3 comprise two series of photomicrographs showing both "crater" and "fatigue-type" pits after an initial test duration, and then again after considerable additional testing. The fact that neither their shape nor their depth profile (as shown by detailed "proficorder"* tracings⁵ change during additional testing, is taken as strong evidence that these pits are indeed "single-event" failures.

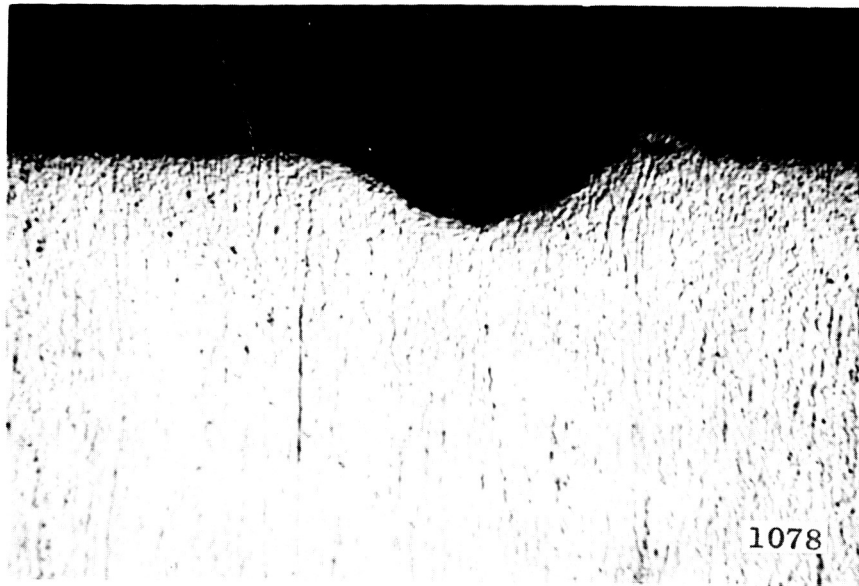
FIGURE 4: Microsection Through Cavitation Pit, (Shown in Figure 8) for "Nose" Cavitation in Mercury at a Throat Velocity of 48 feet/second, Duration 50 Hours. Material is Columbium-1% Zirconium. Etched. Magnification - 1000X

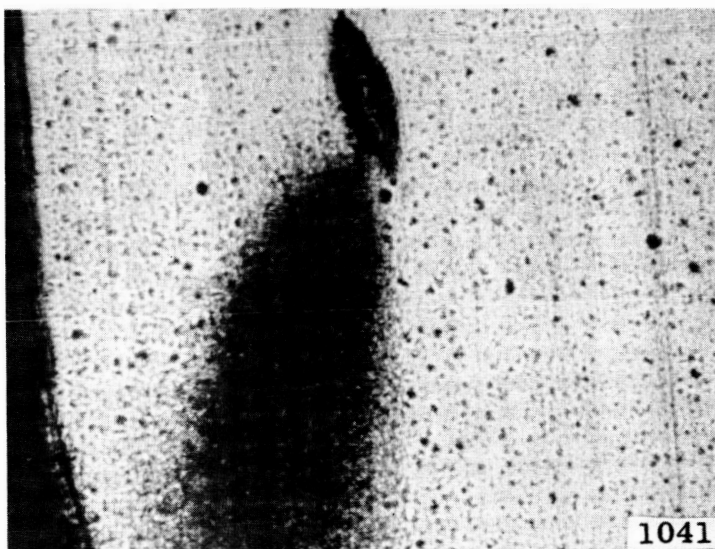
FIGURE 8: Cavitation Pitting in Columbium-1% Zirconium After 50 Hours Exposure to "Nose" Cavitation in Mercury at a Throat Velocity of 48 feet/second. Magnification 120X
